## Welcome to the first quarter newsletter for 2020.

This newsletter includes the quarterly organisational leader board (January to March 2020), STMS of the month for January, February and March 2020 along with feature articles, TTM crash reporting, sign of the month, and some important useful links and email addresses.

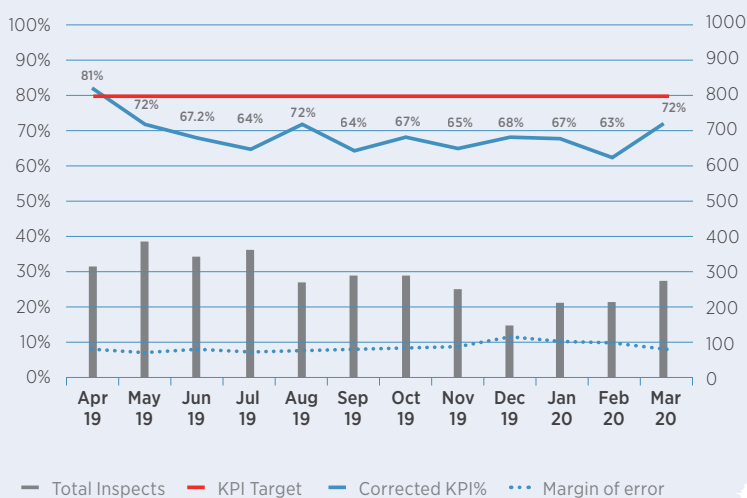
#### Temporary Traffic Management Performance

Each month we report Key Performance Indicators (KPI) of TTM Compliance across the network. One KPI we report is the percentage of “Satisfactory TTM Sites”.

A Satisfactory TTM Site is defined as those reviewed with a High Standard, Acceptable or Needs Improvement result. Graph 1 pictured below shows the tracking of this KPI. We can provide data to organisations (Principal, Main Contractor or TTM organisation) on request. Please feel free to request data. However, please note that detailed information regarding competitors or those from other organisations that the information is pertaining to, will not be issued.

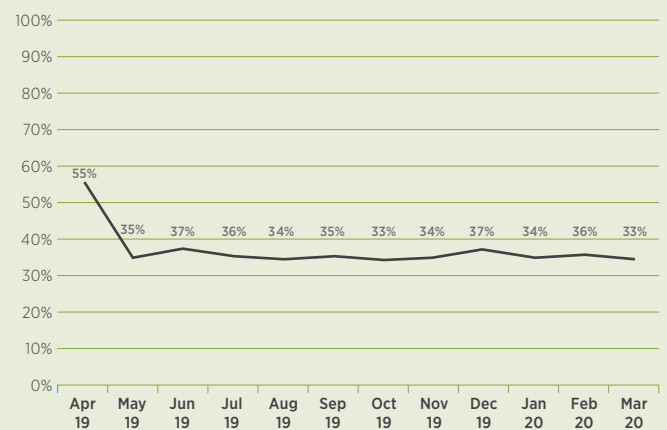
The following graph indicates the approval percentage for CAR applications on their initial submission. This is calculated from the data recorded in My Worksites, as applications are either put on hold or rejected for various reasons.

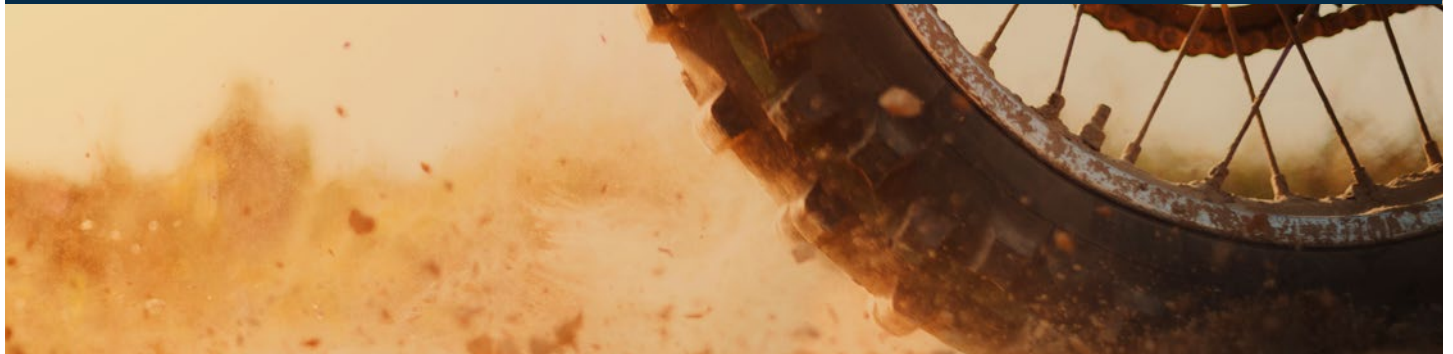
# Crash Study – Motorcyclist Accident

A motorcyclist was riding through a worksite which had a partial road closure with a detour for the opposing direction of traffic. Near a bend in the road, they suddenly encountered an emergency vehicle travelling towards them against the traffic flow. The motorcyclist diverted into the non-active workspace and lost control of their motorcycle, when they collided with a stock pile of loose aggregate. Fortunately, the rider only suffered minor abrasions and there was only minor damage to their motorcycle.

Some of you may have heard of the swiss cheese incident occurrence model. Most crashes are caused by several or many control failures, failures to act or latent conditions. As a result, the negative outcome could have been avoided or prevented simply removing or changing one of the many layers of swiss cheese (controls or causations).

## What could have been done differently that would prevent this happening? Possible root causes / factors in this crash are, but not limited to the following:
